The Active Faults of Harris County: A Self-paced Field Guide

By Mustafa Saribudak and Caroline Wachtman

INTRODUCTION

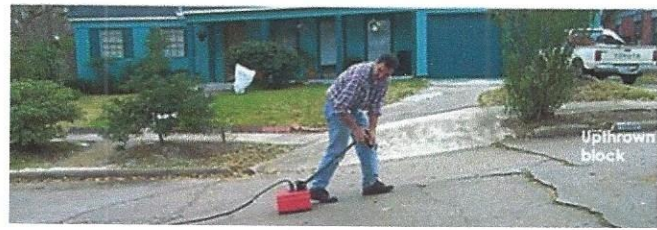
Figure 6. Resistivity imaging data taken along Moorehead Drive across the Long Point fault. Note the fault offset in the southeast direction which juxtaposes the sand and clay layers.

Ground Penetrating Radar (GPR) surveys were performed across the fault (**Figure 6**). The 400-MHz antenna was used with a cart system to collect GPR data. The ability of a GPR system to work successfully depends upon two electrical properties of the subsurface, electrical conductivity and relative dielectric constant. The value of dielectric constant ranges between 1 (for air) and 81 (for water). The dielectric constant for sandy soils, depending on its moisture content, varies 6 to 20. However, the dielectric constant of clay is much higher than sandy soil and ranges between 10 and 40. For this reason, the presence of clay absorbs the electromagnetic signals of GPR and limits its exploration depth.

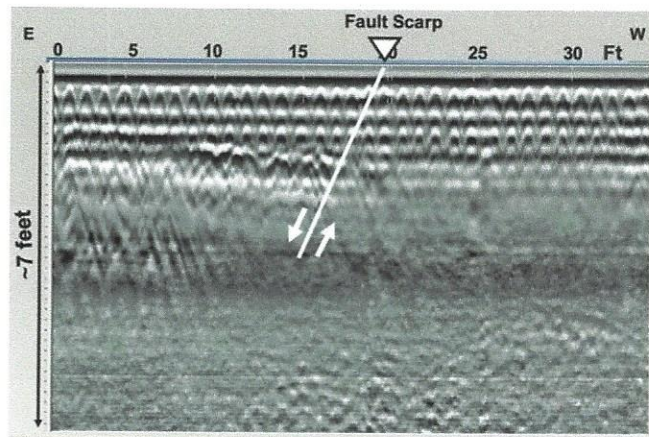
Figure 7. The GPR data across the Long Point fault. The deformation caused by the fault is visible between 7 and 25 feet. Hyperbolic anomalies are due to rebar reflections.

The GPR data is shown in **Figure 7**. The GPR data is displayed in a black-and-white amplitude format. The high amplitude values are shown by the white color, which are mostly caused by the presence of rebar in the subsurface and the underlying clay. Rebar was likely placed within the pavement to minimize the effect of faulting across the road. Despite the heavy presence of rebar and high conductivity soil

layer (high dielectric constant) the GPR profile clearly indicates the downthrown section of the fault.

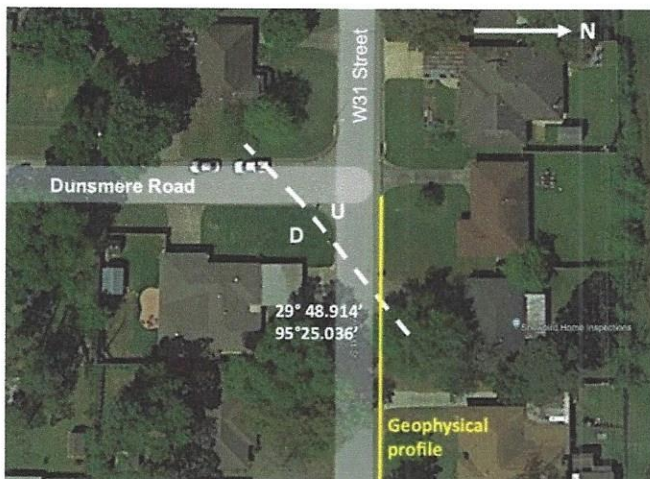
Figure 8. Site map showing the approximate location of the Eureka fault crossing West 31st Street and Dunsmere Road. Fault deformation is highly visible on the asphaltic pavement of West 31 Street. The yellow line indicates the location of geophysical profiles.

Geologic overview: The fault crosses West 31st Street and Dunsmere Road (Figure 8). Fault deformation is expressed as cracks on West 31st street that extend 75 feet across the intersection. The fault is about seven miles long. It crosses many residential places and commercial buildings.

Resistivity and GPR were conducted along the North edge of West 31st Street (Figures 8 and 9). Collecting these data were challenging due to the location of utilities, and insufficient contact between electrodes and fill material in driveways (see Figure 8). However, the resistivity data indicates a significant fault anomaly (Figure 10). In Figure 10, the blue color is interpreted to represent clay lithology and the shape of the blue anomaly is interpreted to represent fault offset.

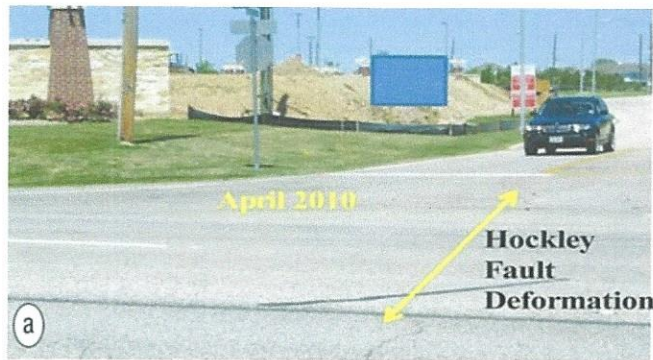
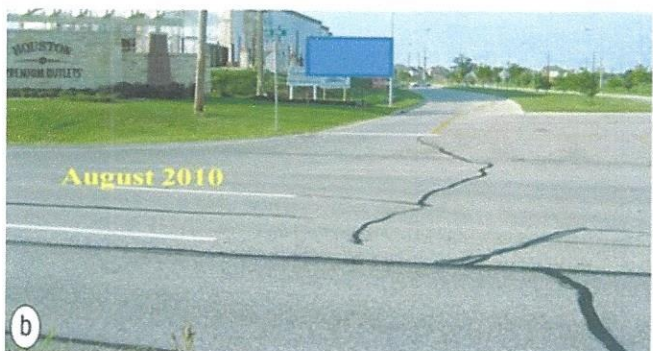
Figure 14. Recent pictures of Hockley fault at Highway 290 Frontage and Fairfield Falls Way roads: (a) taken in April 2010 and (b) taken in August 2010. Note the development of the tiny cracks in (a) into significant cracks in (b).

Visits during April and August 2010 to the Hockley fault site provide additional evidence in the rate of fault deformation (Figure 14). Small cracks in the pavement over the main fault trace photographed in April 2010 and had extended and widened significantly by August 2010. Note that the cracks in Figure 14 have been filled with asphalt. A site visit to the Hockley fault in 2022 showed that cracks were covered with an asphaltic patch.

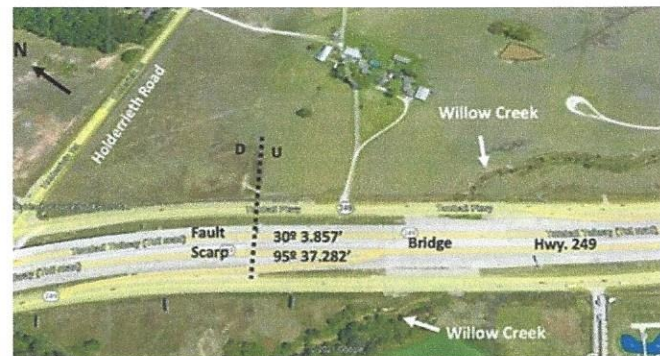
Figure 19. Site map showing the location of Willow Creek fault, which is located between Willow Creek and Holderrieth Road. Note that willow Creek makes a sharp turn across the interpreted fault location. There were also asphalt patches to the South of the Creek and on the bridge. It is interesting to note that the farmland to the northeast (where the farmhouse is located) is undeveloped.

Location: Coordinates of the Willow Creek fault are 30° 3.857', 95° 37.282'. It is located on Highway 249 (Tomball Parkway) between Willow Creek and Holderrieth Road (Figure 19). The fault location is about 4,800 ft to the North of Grand Parkway (Highway 99). In 2003, a discrete rupture was visible on both bounds of the highway (Figure 20).

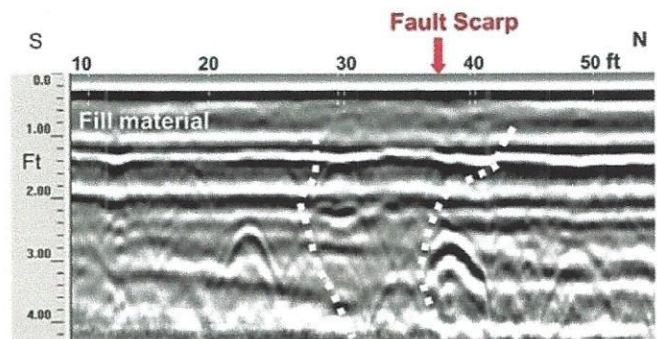
Figure 23. The GPR data across the scarp of the Willow Creek fault. The data are interpreted to show minor deformation that is less significant than observed at the Long Point, Eureka Heights or Hockley faults. However, the disruption of sedimentary layers is interpreted to be visible. Hyperbolic anomalies could be due to buried pipes.

A GPR survey profile collected across the fault scarp along profile L2 and is provided in Figure 23. The GPR data indicates discontinuous layers beneath the scarp at a depth of 2 feet that are interpreted to result from deformation. In addition, the published GPR data (Saribudak and Nieuwenhuis, 2006) detected differential subsidence and a deformation zone between the bridge and the footing of the bridge. The Willow Creek fault movement is a possible cause for this deformation.
